Limited Initial Assessment

**205 E Burleigh Blvd.
Tavares, FL 32778**

AMRC Project # 24-080832-IAQ

August 27, 2024

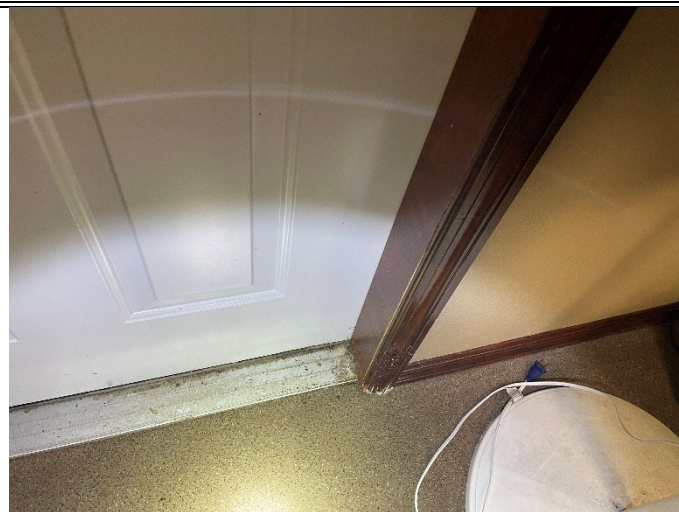
Break Room/ Electrical Room	<ul style="list-style-type: none"> ◦ A malodor was not observed. ◦ Slight water damage (paint delamination) was observed at the base of the rear exit door frame in the electrical room. ◦ Visible suspect mold growth was not observed. ◦ Elevated moisture was detected in the drywall below the break room window and rear wall and in the drywall on the left wall (near front corner) in the electrical room. 	<ul style="list-style-type: none"> ◦ Under containment, remove the drywall from the left and rear break room walls from the floor to the windowsill and extend four feet (4') in length. ◦ Under containment, remove the drywall from the left electrical room wall from the floor up five (5') and extending two feet (2') in length from the front wall. ◦ Continue removing materials as needed a minimum of two feet beyond visible mold, water staining, and/or wet materials. ◦ Monitor the rear exit door frame for discoloration. If discoloration appears, remove the door trim. ◦ Conduct water testing to identify point(s) of water intrusion and repair as needed.

Photo 39: Water damage was observed at the base of the rear exit door trim.

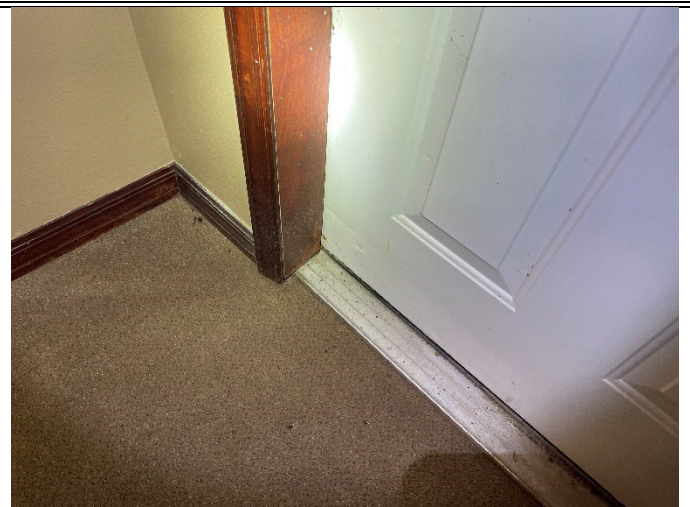
Photo 40: Water damage was observed at the base of the rear exit door trim.

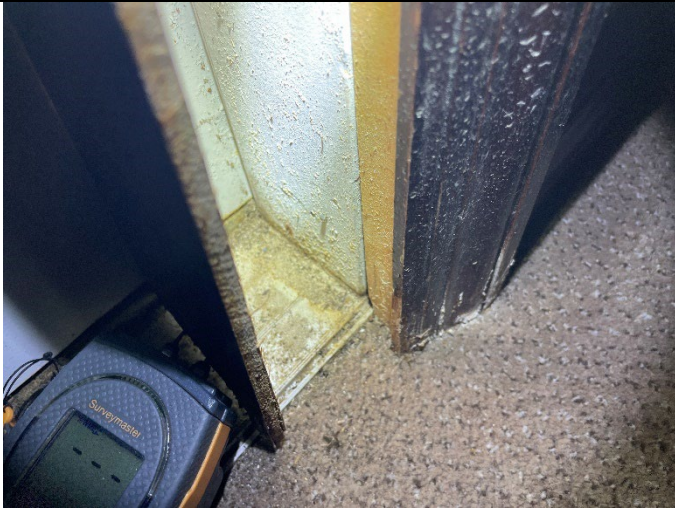
Photo 41: Visible suspect mold growth was observed at the base of the rear exit door frame behind the trim.

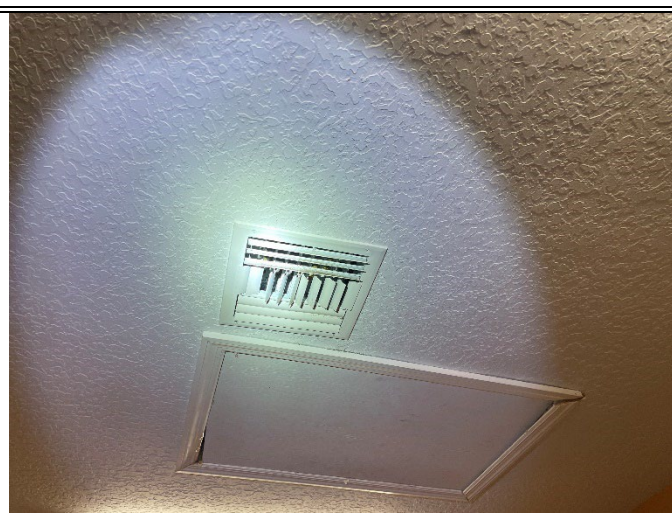
Area/Room	Observation	Recommendation**
Office 4	<ul style="list-style-type: none"> ◦ A malodor was not observed. ◦ Water staining/damage was not observed. ◦ Visible suspect mold growth was observed on the supply vent next to the attic hatch. ◦ Elevated moisture was not detected. 	<ul style="list-style-type: none"> ◦ Clean the vent by HEPA filter vacuuming and wiping with a detergent cleaner.
Office 5	<ul style="list-style-type: none"> ◦ A malodor was not observed. ◦ Water staining was observed on the ceiling below the air handler. ◦ The ceiling was bowed downward below the air handler. It was reported that this is a repeat impact that has not occurred within the last 3 years. The attic has a plywood floor, and the topside of the drywall was inaccessible. ◦ Elevated moisture was not detected. 	<ul style="list-style-type: none"> ◦ If needed, remove the impacted ceiling two feet beyond the bowing.

Photo 46: Visible suspect mold growth was observed on the supply vent next to the attic hatch.

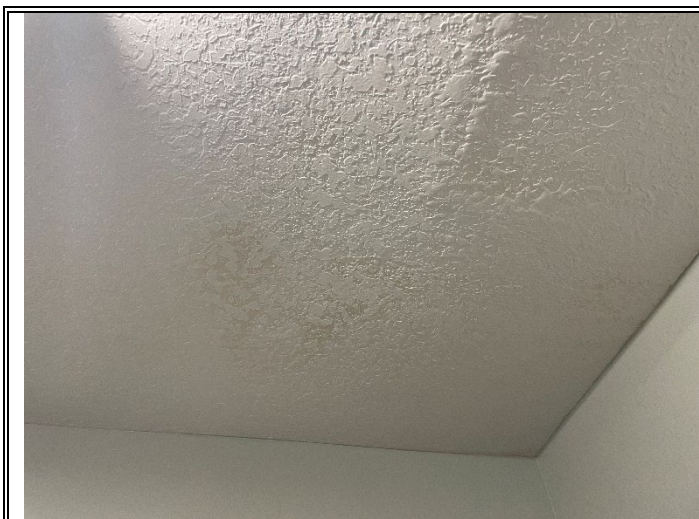
Photo 49: Water staining was observed on the ceiling below the air handler.

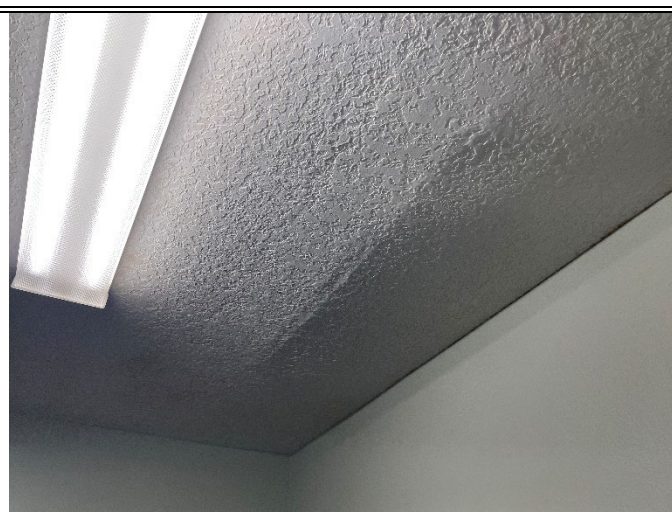
Photo 50: The ceiling was bowed downward below the air handler.

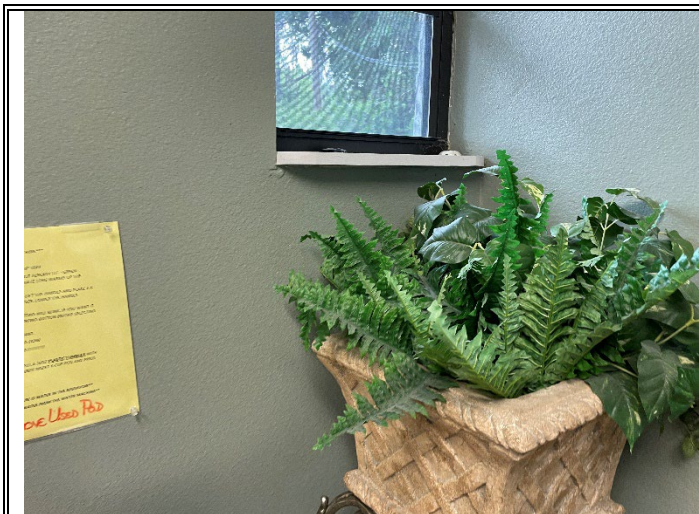
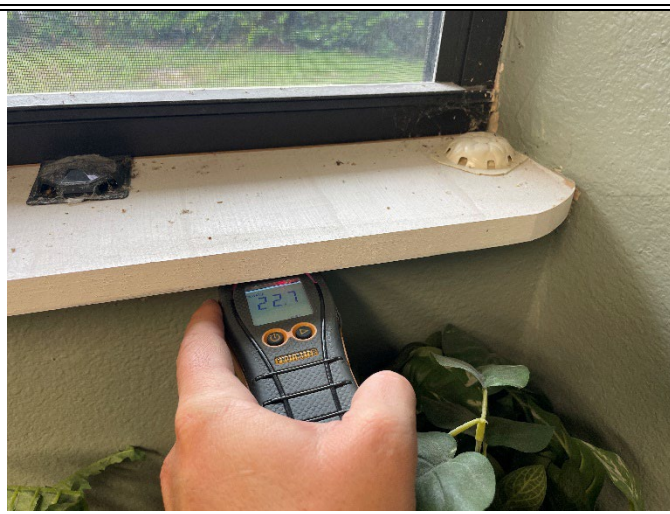
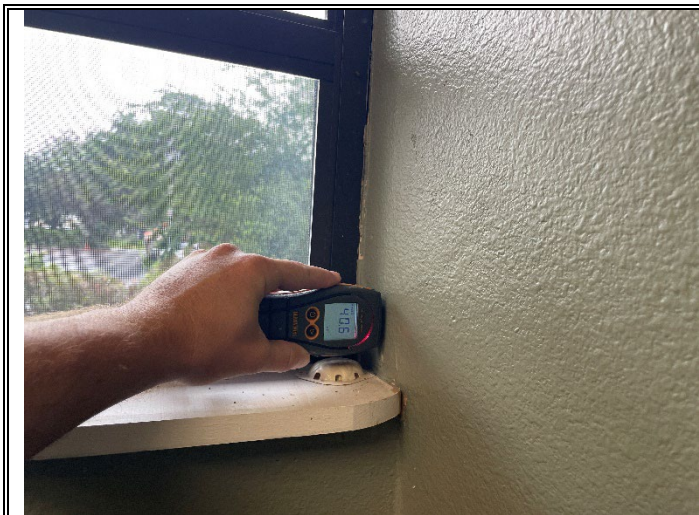
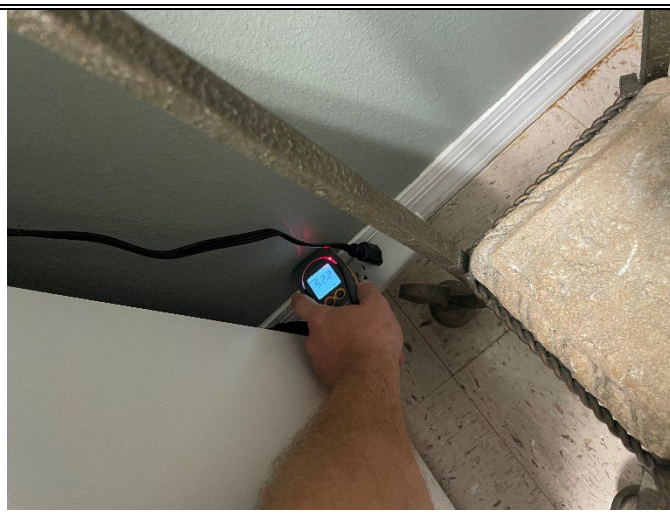
Photo 53: Elevated moisture was detected in the drywall below the break room window and rear wall.

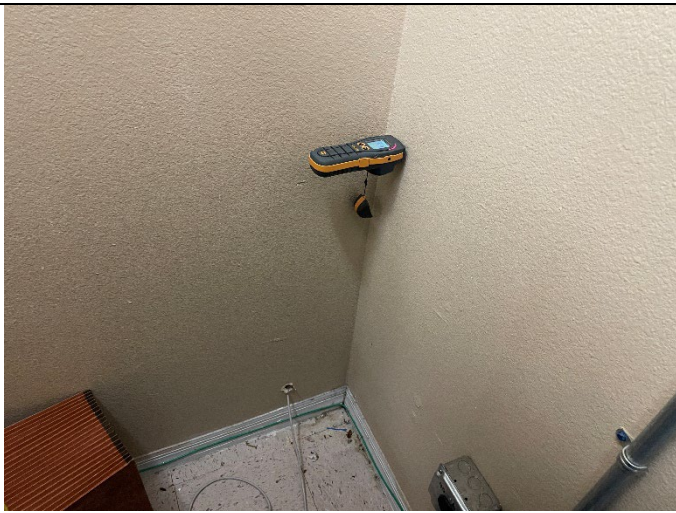
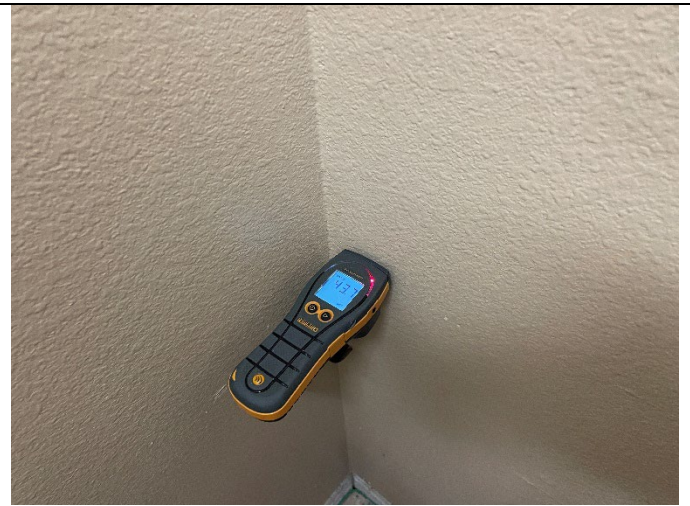
Photo 57: Elevated moisture was detected in the drywall on the left wall (near front corner) in the electrical room.

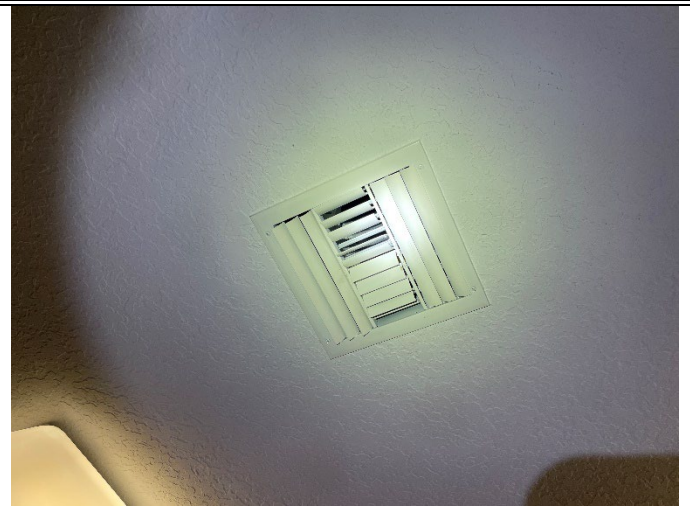
Lobby	<ul style="list-style-type: none"> ◦ A malodor was not observed. ◦ Water staining/damage was not observed. ◦ Slight visible suspect mold growth was observed on the supply vent. ◦ Elevated moisture was not detected. 	<ul style="list-style-type: none"> ◦ Clean the vent by HEPA filter vacuuming and wiping with a detergent cleaner.
◦The directions/locations within the rooms provided in the table above are given assuming you are standing outside looking at the entry door.

Photo 60: Slight visible suspect mold growth was observed on the supply vent.
