Confidential Inspection Report

Prepared for: Terry Yonker Subject Property: 275 S US Hwy 1792, Longwood, Fl 32750.

INSPECTION REPORT

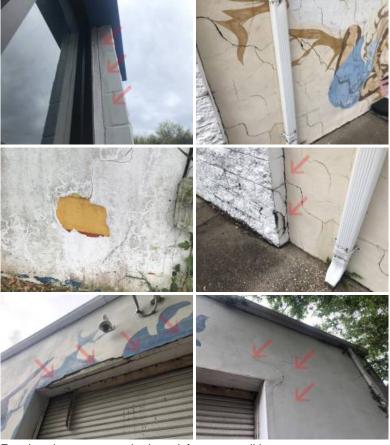
Stucco finish loose or hollow - left side of structure. Stucco appears to have separated from the underlying substrate. I recommend evaluation by a qualified tradesperson to determine appropriate corrective measures and cost to cure.

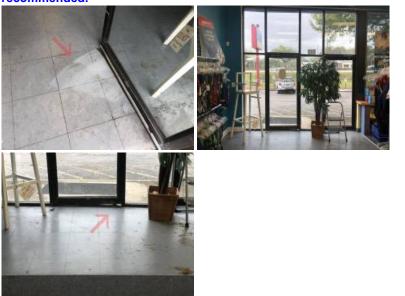
Main entry and exit door glass area appears to be racked and no longer level. Flooring in entry way area appears to be sloped from exterior wall towards the center of the structure. Evaluation and repair by a qualified tradesperson recommended.

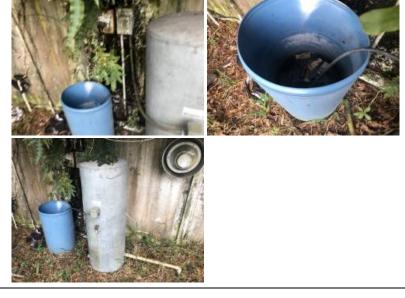
Municipal Supply. Left side of structure. Main water shut off valve is functional. Water pressure measured between 40 to 80 pounds per square inch which is considered within normal/acceptable range. *Well and pump equipment appears to be no longer in use.*

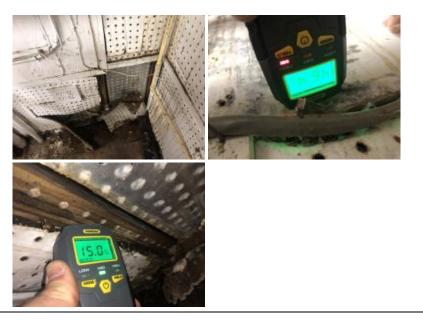
Interior wall in the back right corner of large storage area is located directly under active roof leak. Walls are damaged and deteriorated. Area was tested with an electronic moisture meter and elevated moisture levels were found. Repair and maintenance recommended.

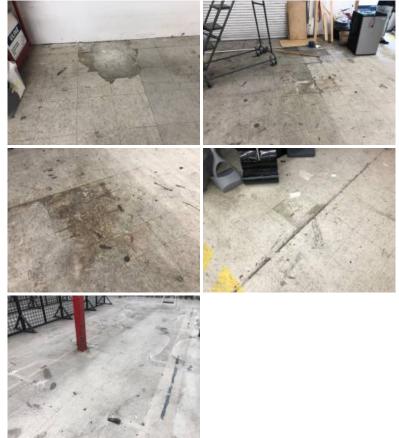
Laminate Tile. Tile floor is damaged in multiple locations. Maintenance and repair recommended.
