Reference: Preliminary Geotechnical Exploration  
 Proposed Auto Repair Buildings  
 S.R. 426 - Aloma Avenue  
 Oviedo, Seminole County, Florida  
 UES Project No. 13391-001-01  
 UES Report No. 335187

PRELIMINARY GEOTECHNICAL EXPLORATION  
 PROPOSED AUTO REPAIR BUILDINGS  
 OVIEDO, SEMINOLE COUNTY, FLORIDA

BORING LOCATION PLAN

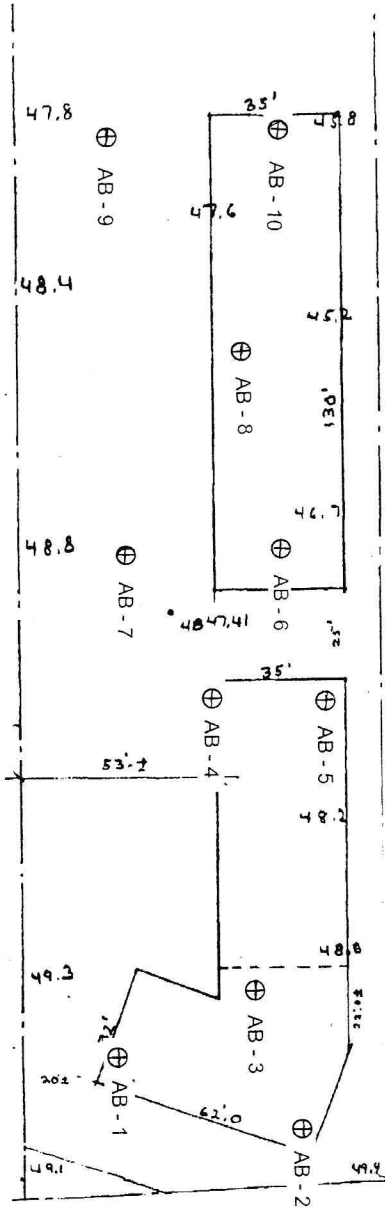
The subject site is approximately .91 acres. Locations of the ten soil borings were randomly selected within the project site based on the site plan provided to us concentrating on the areas of the two proposed buildings to be located on the subject site ( see the attached Site Plan for approximate boring locations). Generally, our borings encountered gray to brown fine sand extending to depths of 13 to 22 inches below the existing ground surface. This material was underlain by light brown to gray fine sand extending to depths of 21 to 38 inches below the ground surface. Beneath this material, we encountered a dark brown to brown sand with silt extending to the boring termination depths of 42 to 66 inches below the existing ground surface. At three of our boring locations (AB-7, AB-9, and AB-10), we encountered a surficial layer of organic sand extending from the ground surface to 6 to 9 inches below grade. The organic content of this material was found to range between 4.7% and 5.1% and the moisture content of the material is 36%. The groundwater table was encountered at depths ranging from 24 to 37 inches below the existing ground surface at our boring locations. We estimate the seasonal high groundwater table to be approximately 12 inches below the existing ground surface at our boring locations.

During our field exploration, we encountered a surficial layer of organic sand in borings AB-7, AB-9 and AB-10, located in the western most third of the subject site. It is our professional opinion that the organic sand be removed prior to construction of the proposed buildings. Due to the surficial depth, approximately 6 to 9 inches below the existing ground surface, and the low organic content of the material, the normal site preparation and clearing process should be sufficient to remove all this unsuitable material.
