December 20, 2004

**Kendar Corporation**  
441 Cortez Road W.  
Bradenton, Florida 34207

Subject: **PHASE I ENVIRONMENTAL SITE ASSESSMENT**  
Ramada Inn  
6502 Surfside Boulevard  
Hillsborough County, Apollo Beach, Florida  
*HSA Project Number 60-15-3441-00*

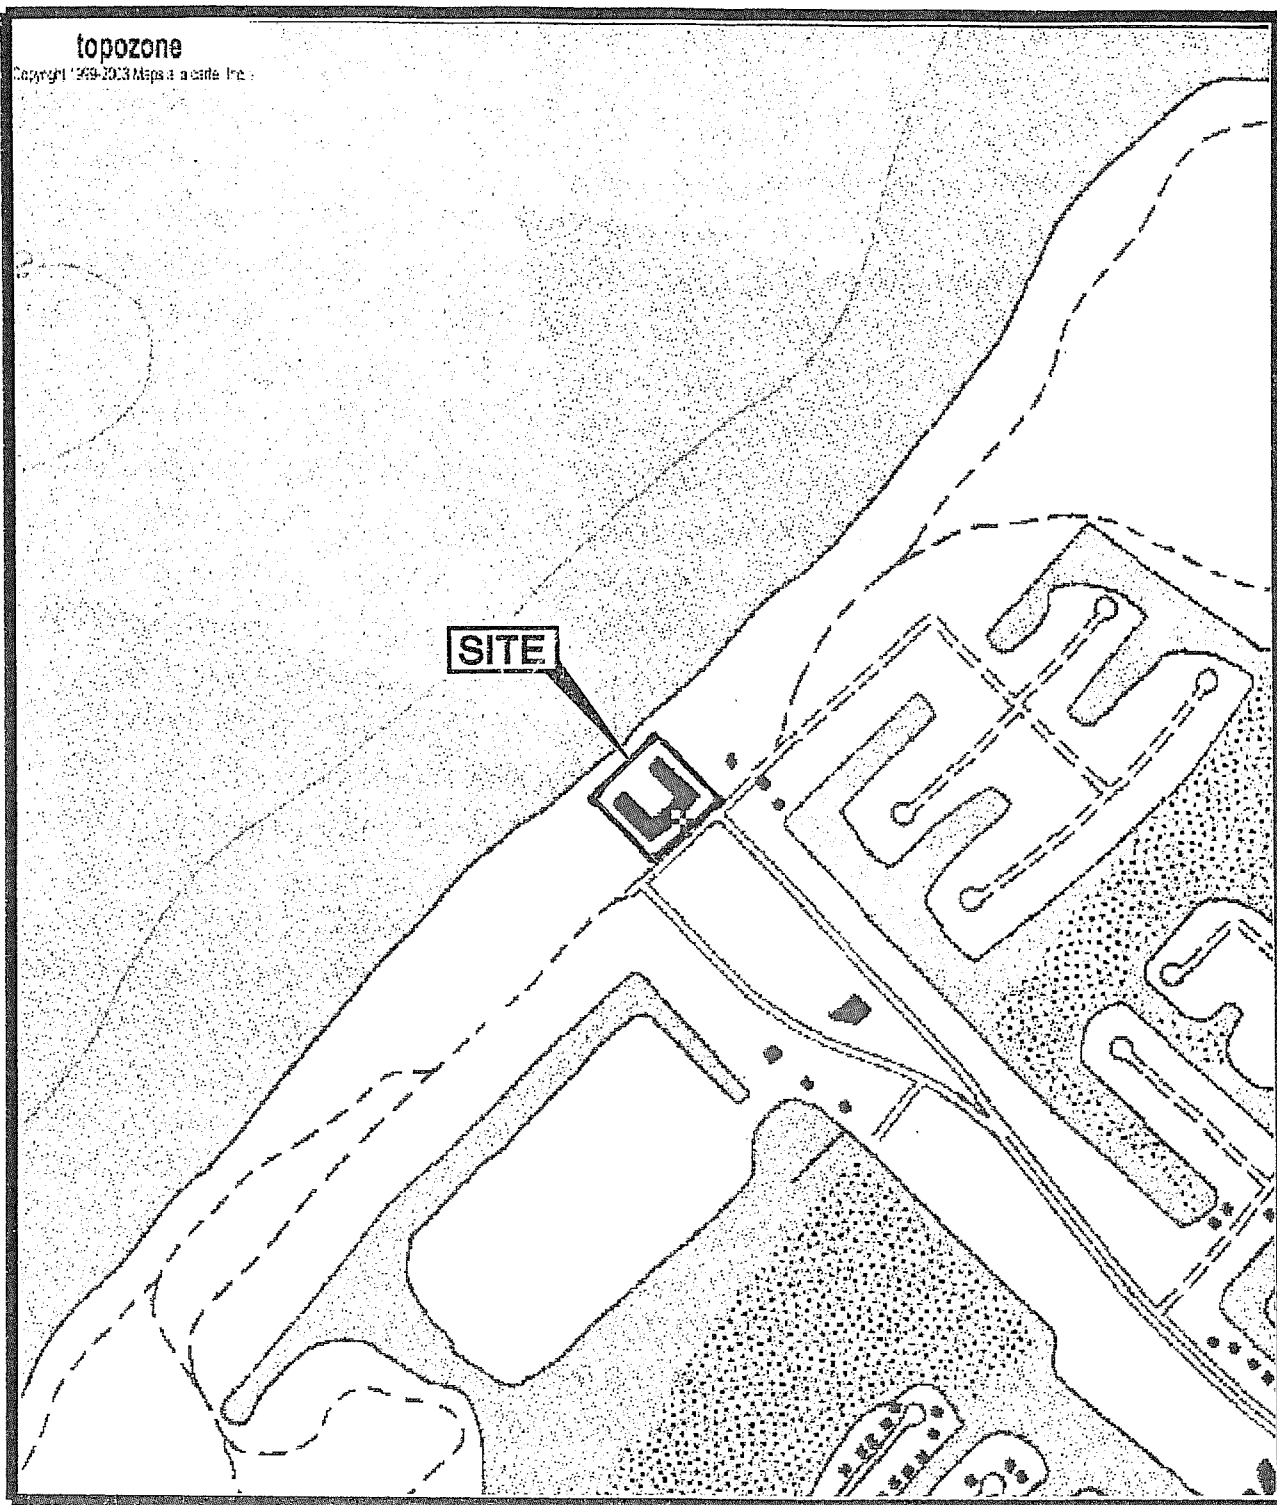
SOURCE: GIBSONTON, FLA., U.S.G.S. QUADRANGLE MAP 1987

A current USGS 7.5 Minute Topographic Map illustrating the area on which the property is located, was reviewed during the ESA (see **Figure 4**). This review is required as specified in ASTM Standard E 1527-00 § 7.2.3. This map is particularly useful when conditions have been identified in which Hazardous Substances or Petroleum Products are likely to migrate to the Property or from within the Property, into the groundwater or soil. The 1974 (photorevised 1987) USGS "Gibsonton, Florida" quadrangle map was reviewed. The subject property is located in Section 17, Township 31, and Range 19 East. According to the topographic map review, the subject property and surrounding areas are located approximately 5 feet above mean sea level.

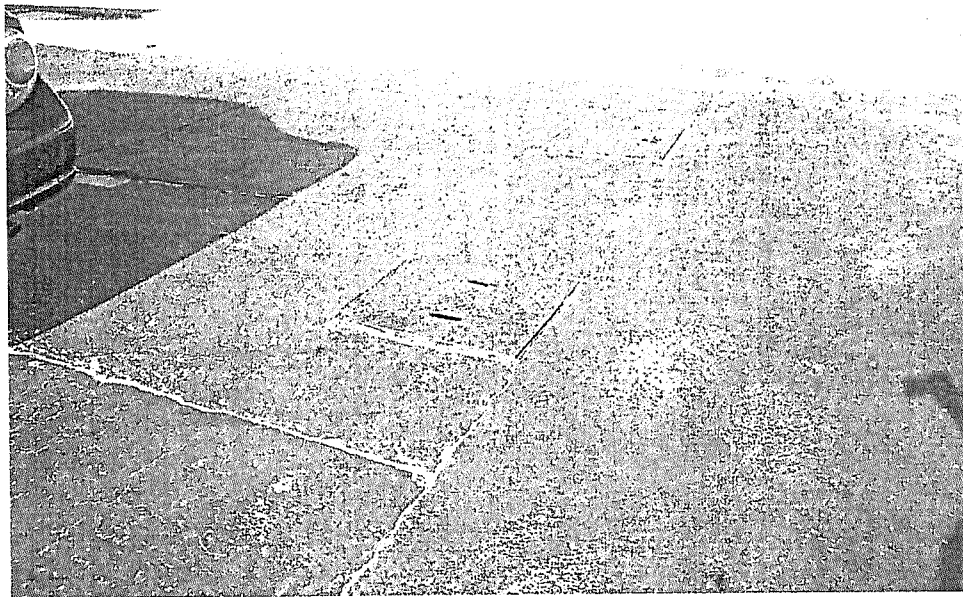
Two manhole covers were observed within the northwest and southeast portions of the parking area (**Appendix D, Photographs 3 and 4**). According to Mr. Caesar (last name withheld), two approximately 500-gallon underground storage tanks (USTs) containing propane fuel are located in these areas. Mr. Caesar indicated that the fuel is utilized as a power source for the kitchen and laundry areas. Two, approximately 300-gallon water heaters were also observed within a storage area located on the southeast portion of the site (**Appendix D, Photograph 5**).

3. View of the propane storage tank area located on the northwest portion of the subject property.

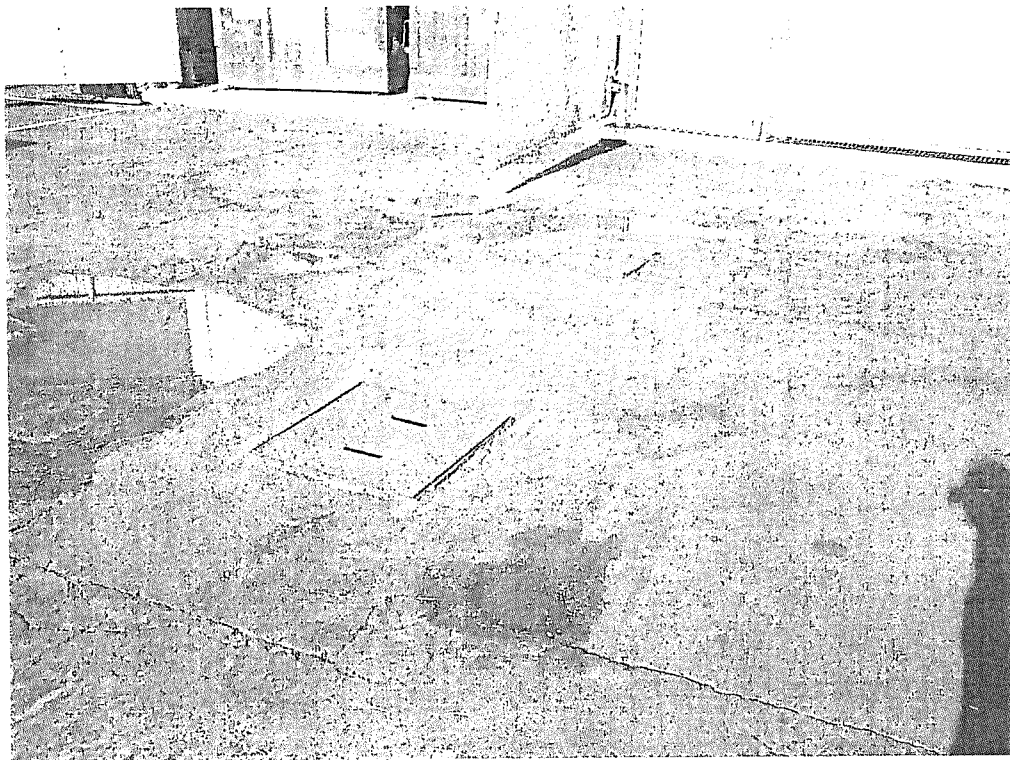
4. View of the propane storage tank area located on the southeast portion of the subject property.

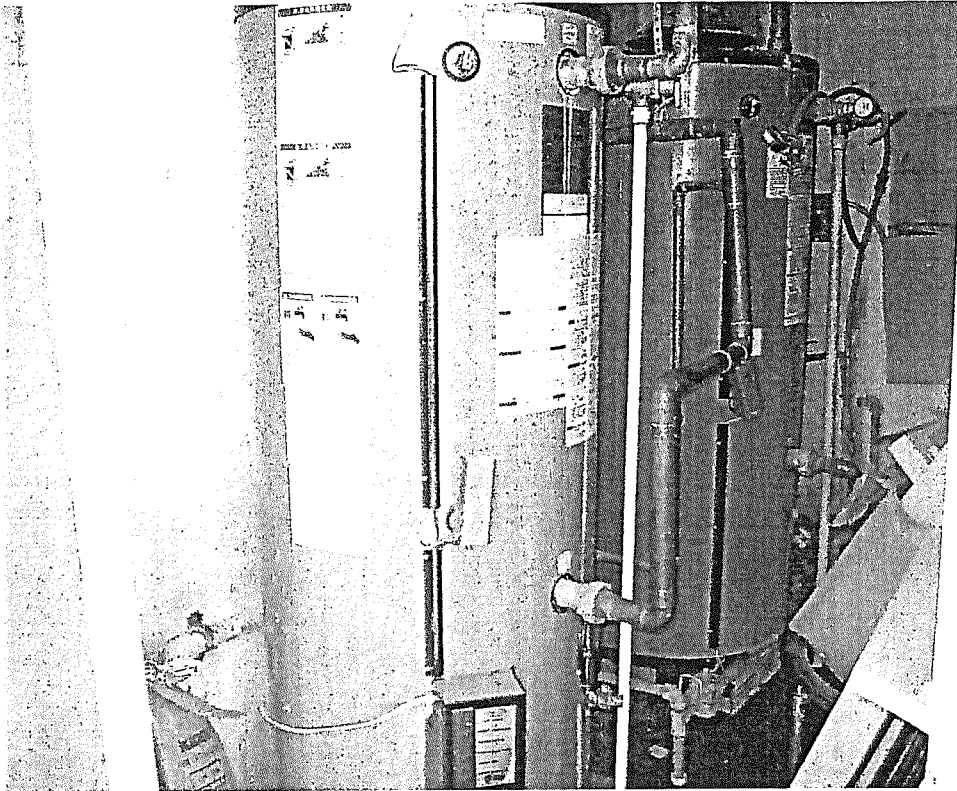
5. View of the water heaters located on the southeast portion of the site.

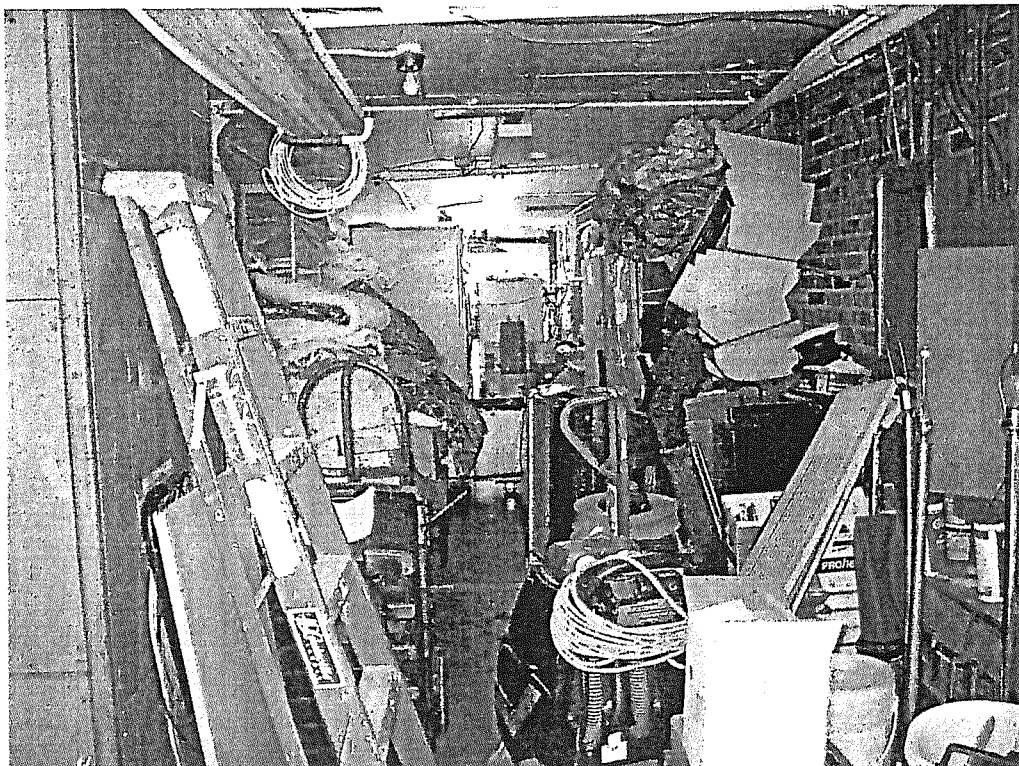
Various household cleaning and maintenance supplies were observed throughout the property. Pool chemicals, including chlorinating solution, were observed within 55-gallon drums located within the pool pump area (**Appendix D, Photographs 6 and 7**). According to Mr. Caesar, the

6. View of the interior of the maintenance/laundry facility.

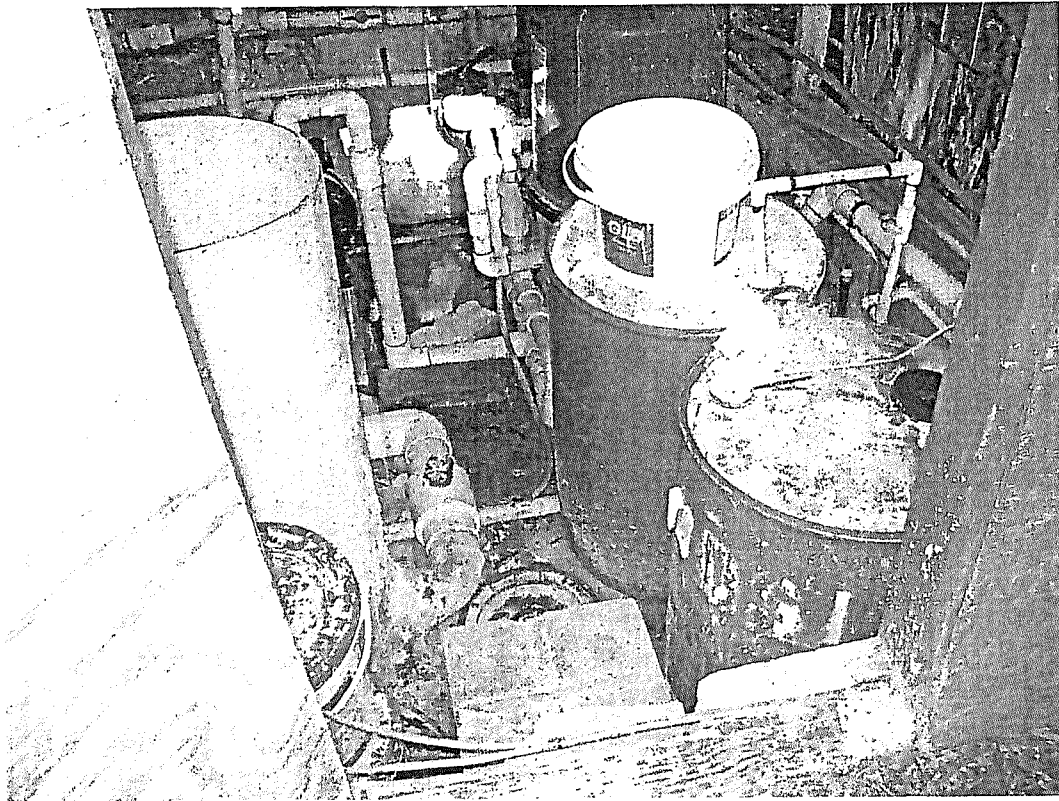
chlorinating solution is pumped through the system. Maintenance supplies were also observed a metal shed and laundry area located on the southeast portion of the site (**Appendix D, Photograph 8**). Several 5-gallon containers of paint and sealers, and various maintenance materials and cleaners in containers of less than 1-gallon in size were observed in the shed. A 1-gallon container of gasoline was also observed within the metal shed. Additionally several household cleaners were observed in the laundry/housekeeping facility. The containers appeared to be sealed and no obvious stains or leaks were observed in or around the containers. Commercial-size dryers and washers were also observed in the laundry/housekeeping area. According to Mr. Caesar, no dry cleaning is performed onsite.

7. View of the interior of the pool pumphouse.

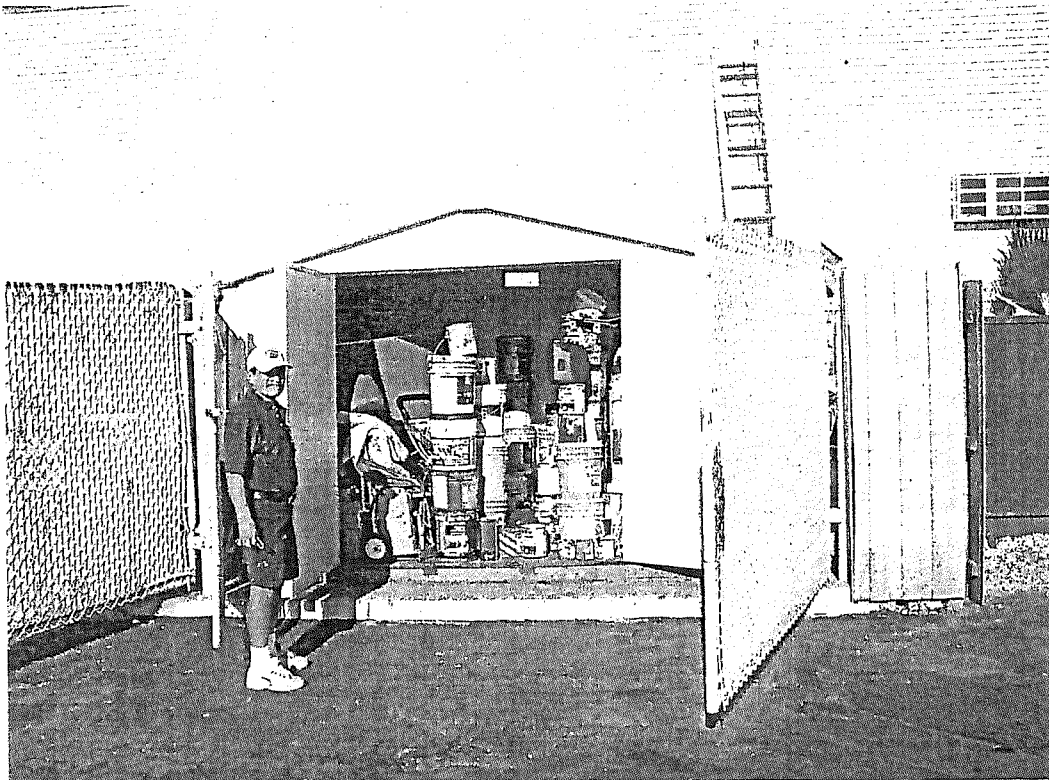
8. View of the metal shed located on the southern portion of the site.
